fitted with K4J, K4M, F4P or F4R engine

Cancels and replaces Technical Note No. 4242A dated JUNE 2002.

17A ENGINE INSTABILITIES (SUPPLEMENT TO TECHNICAL NOTE 4098A)

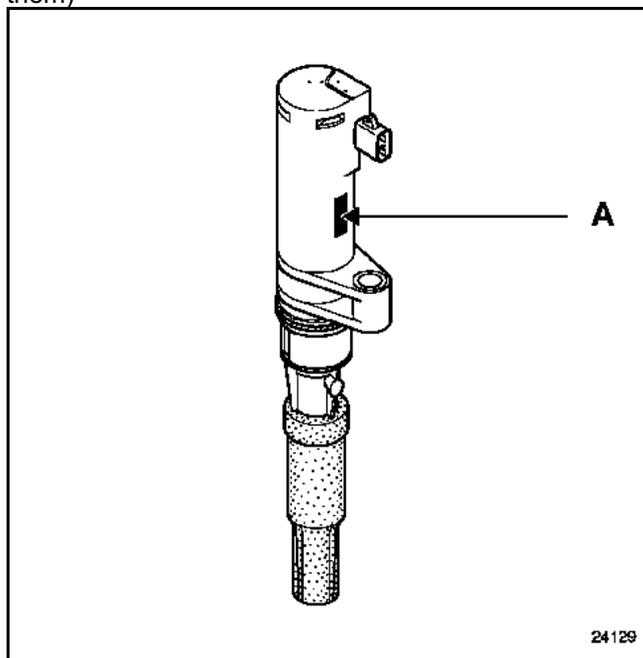
Fig. 1

A – Location of the fabrication date on the ignition coil

- Carry out a detailed fault finding procedure according to Technical Note 4098A.
 - If the fault finding points to a faulty ignition coil:
 - DENSO** ignition coil:
 - Replace only the faulty ignition coil.
 - SAGEM** ignition coil:
 - **Without removing them**, check the fabrication date of the ignition coils (A) (**Fig. 1**).
 - Replace the faulty ignition coil only or all four coils depending on the fabrication date.

Fabrication date	Operation to be carried out
Above 112 - 0 (e.g.: 050 - 1)	Replace the faulty ignition coil(s)
Below 112 - 0 (e.g.: 050 - 0)	Replace all four ignition coils
