# Tutorial

## Drain BVA Aisin Warner TF-80SC (AM6) Citroen C6 3.0 V6 petrol (ES9A) & 2.7 V6 diesel (DT17).

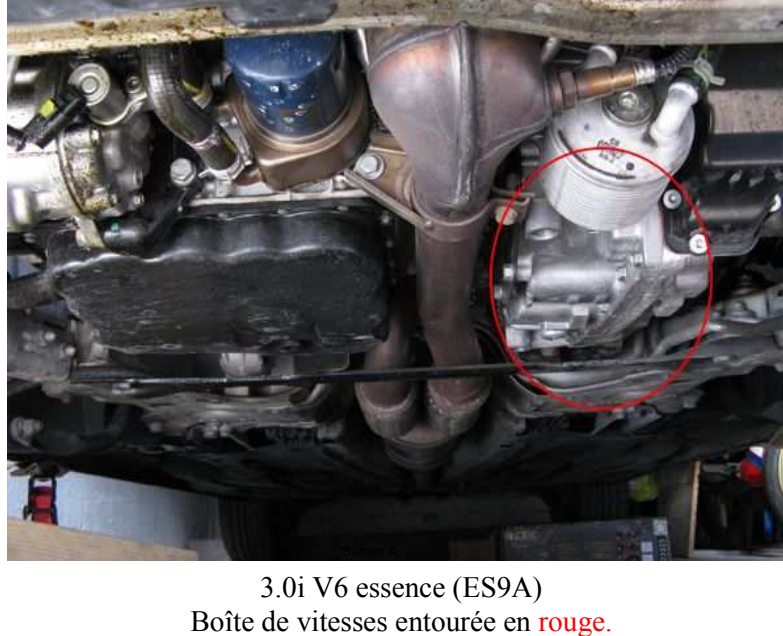
3.0i V6 essence (ES9A)  
Boîte de vitesses entourée en rouge.

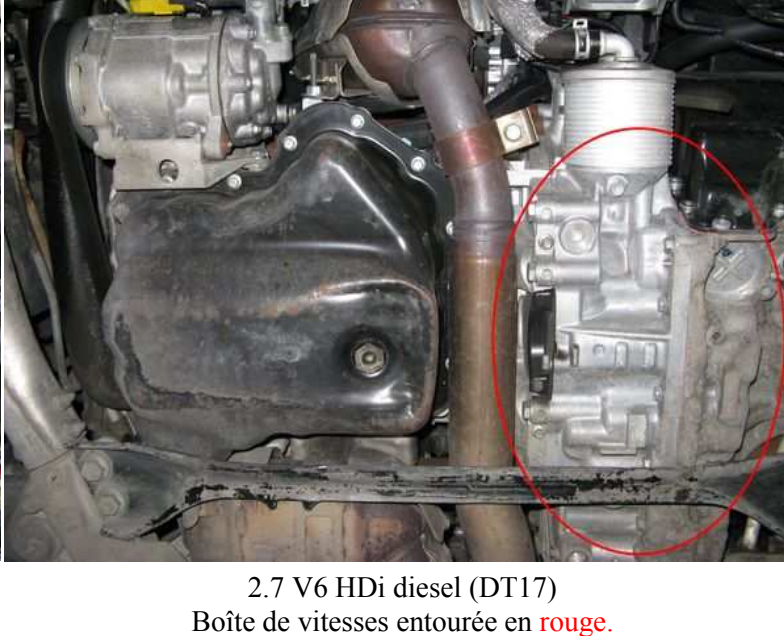
2.7 V6 HDi diesel (DT17)  
Boîte de vitesses entourée en rouge.

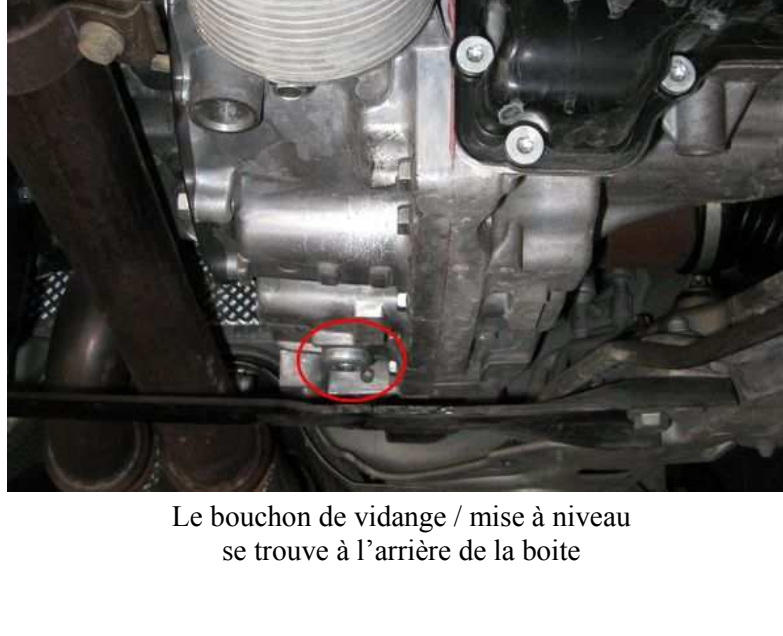
Le bouchon de vidange / mise à niveau  
se trouve à l'arrière de la boîte

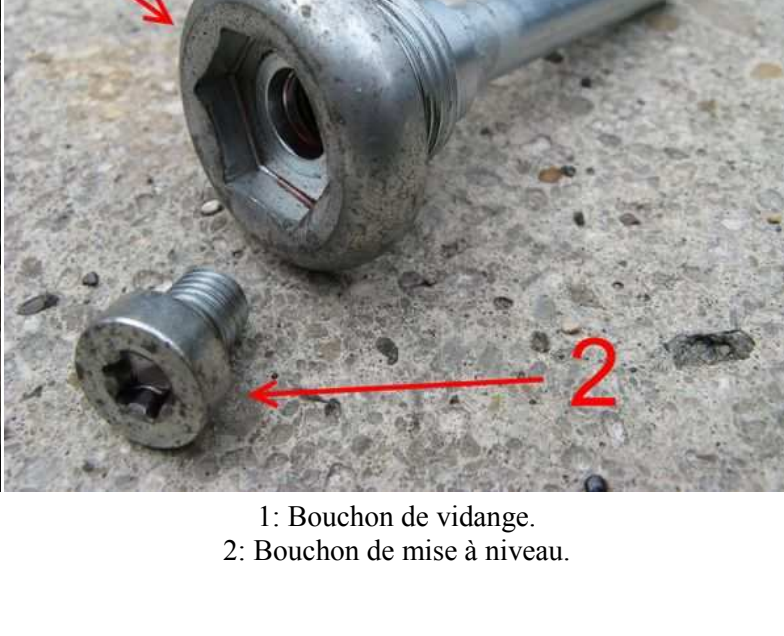
-The plug in the gearbox box consists of 2 parts: A drain plug (1) and a level plug (2).

1: Bouchon de vidange.  
2: Bouchon de mise à niveau.

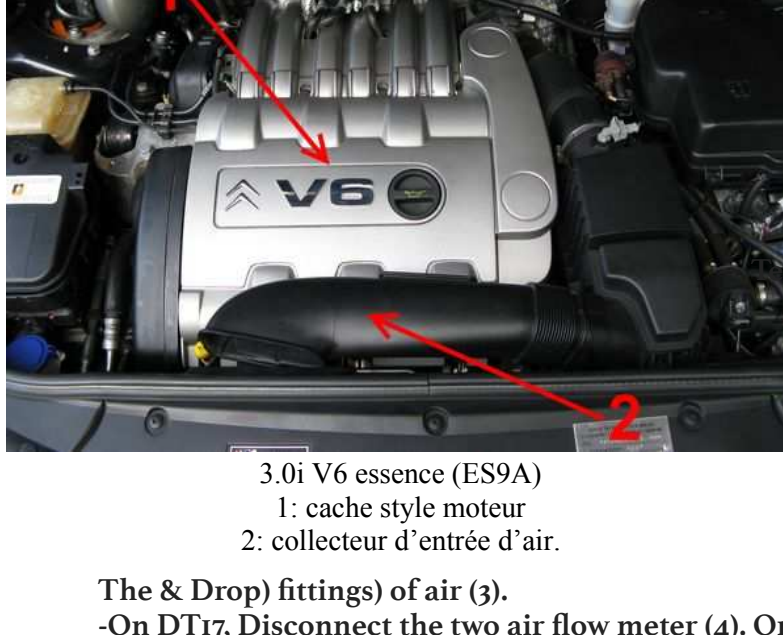
3.0i V6 essence (ES9A)  
1: cache style moteur  
2: collecteur d'entrée d'air.

Remove the engine style cover (at 1). -Remove the air intake manifold (2).

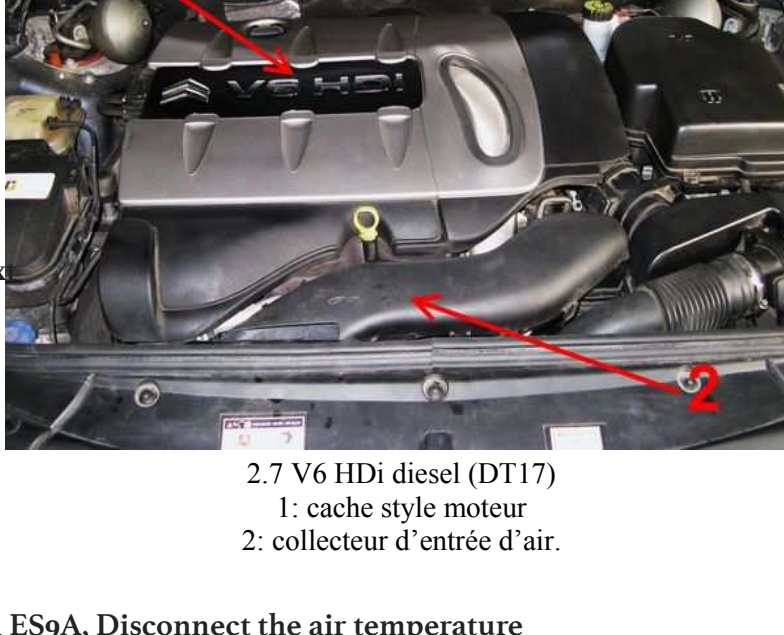
2.7 V6 HDi diesel (DT17)  
1: cache style moteur  
2: collecteur d'entrée d'air.

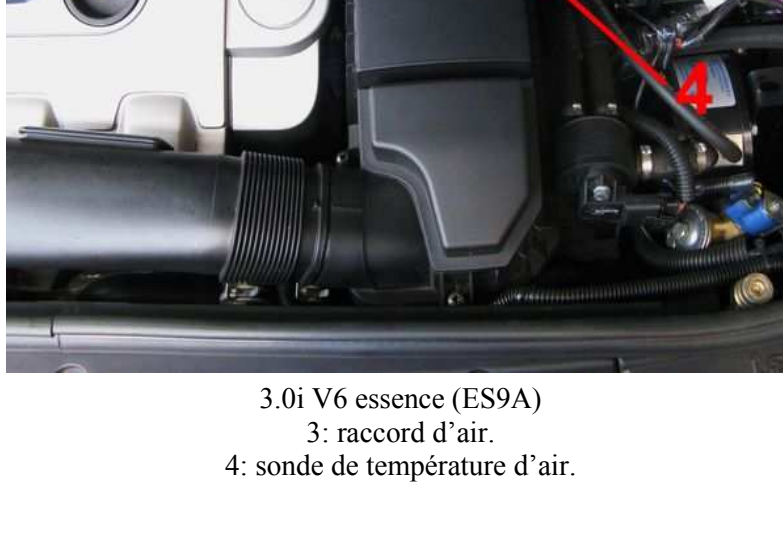
3.0i V6 essence (ES9A)  
3: raccord d'air.  
4: sonde de température d'air.

-On DT17, fitting the two air flow meter (4). On ES9A, Disconnect the air temperature

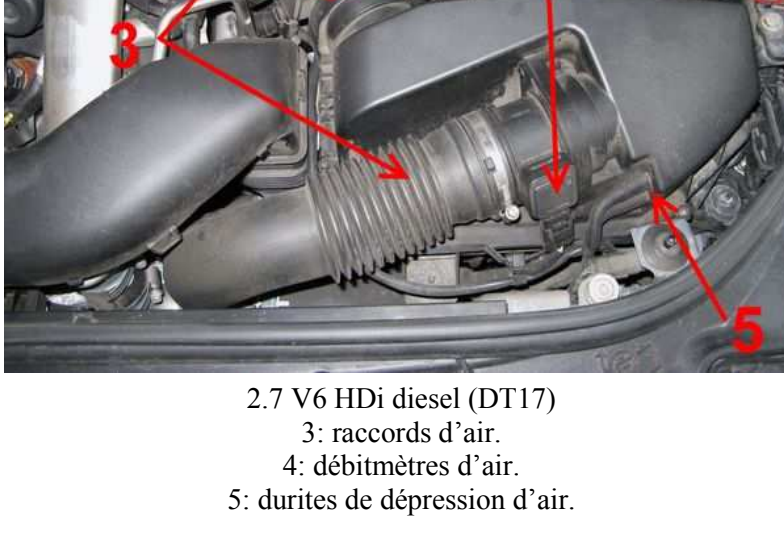
2.7 V6 HDi diesel (DT17)  
3: raccords d'air.  
4: débitmètres d'air.  
5: durites de dépression d'air.

sensor (4) -On DT17, disconnect the 2 air hoses depression (5).

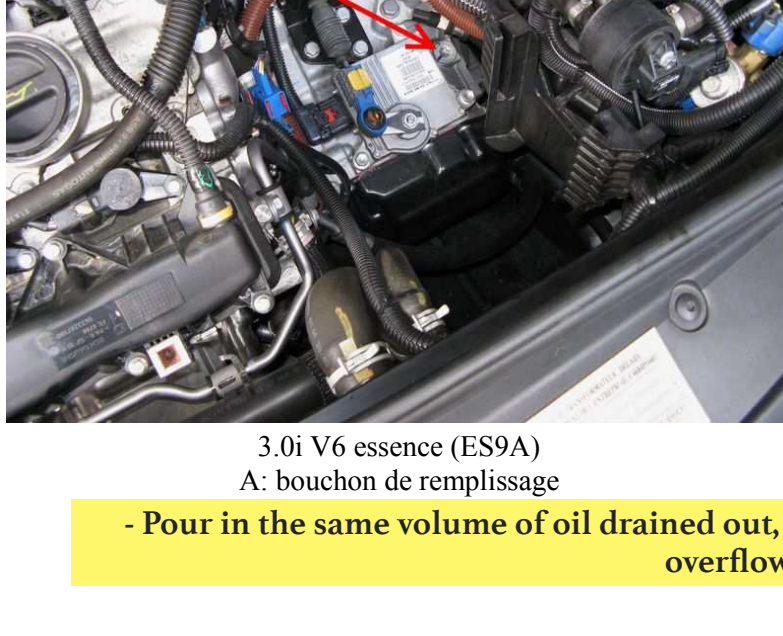
3.0i V6 essence (ES9A)  
A: bouchon de remplissage

-Remove The filler cap (Torx T55).

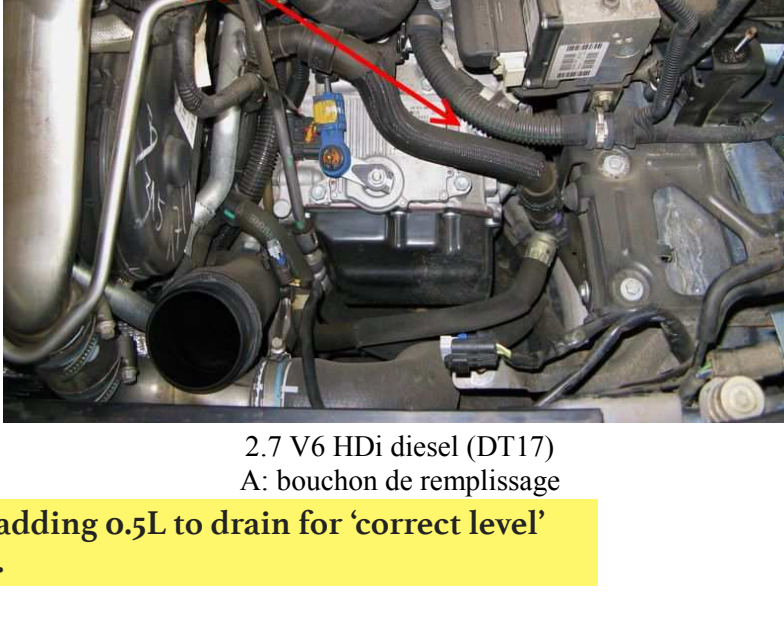
2.7 V6 HDi diesel (DT17)  
A: bouchon de remplissage
