Next we are going to install the valve body back onto the transmission.

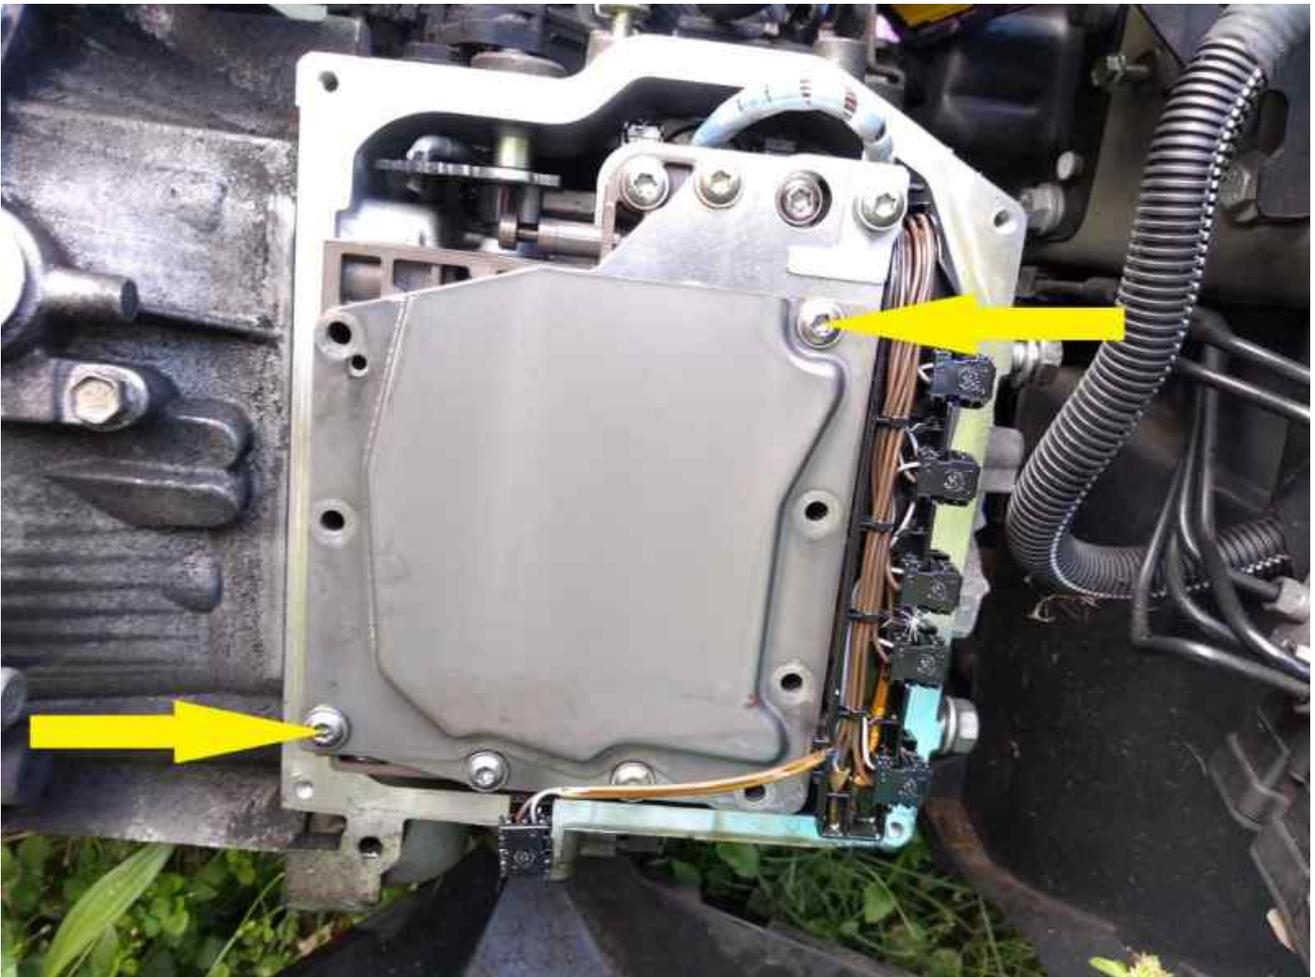
Install the cover and slide 2 of the mounting bolts back into the valve body in positions 4 & 5 .

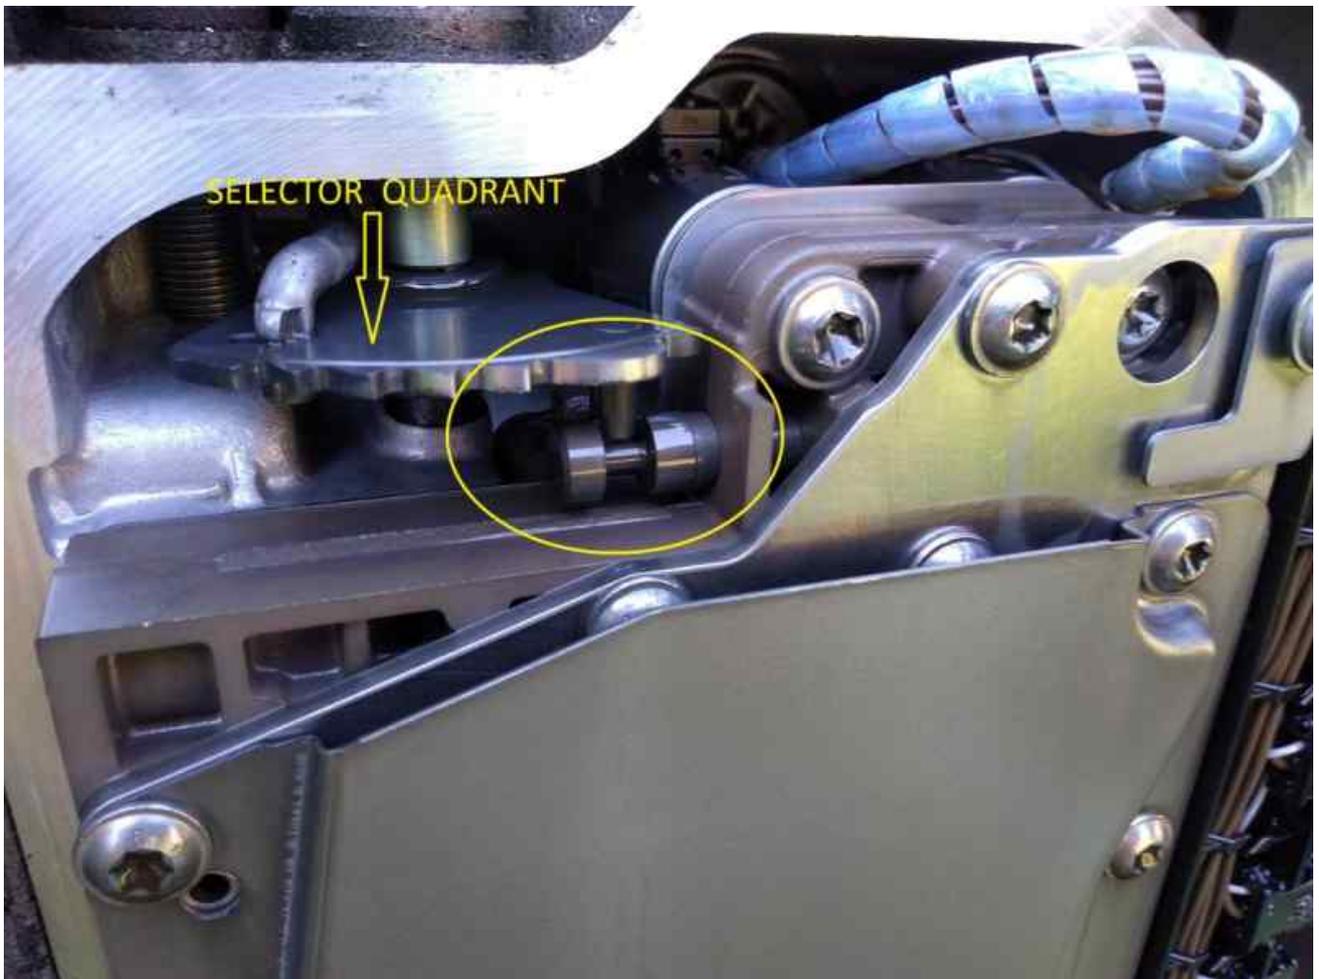
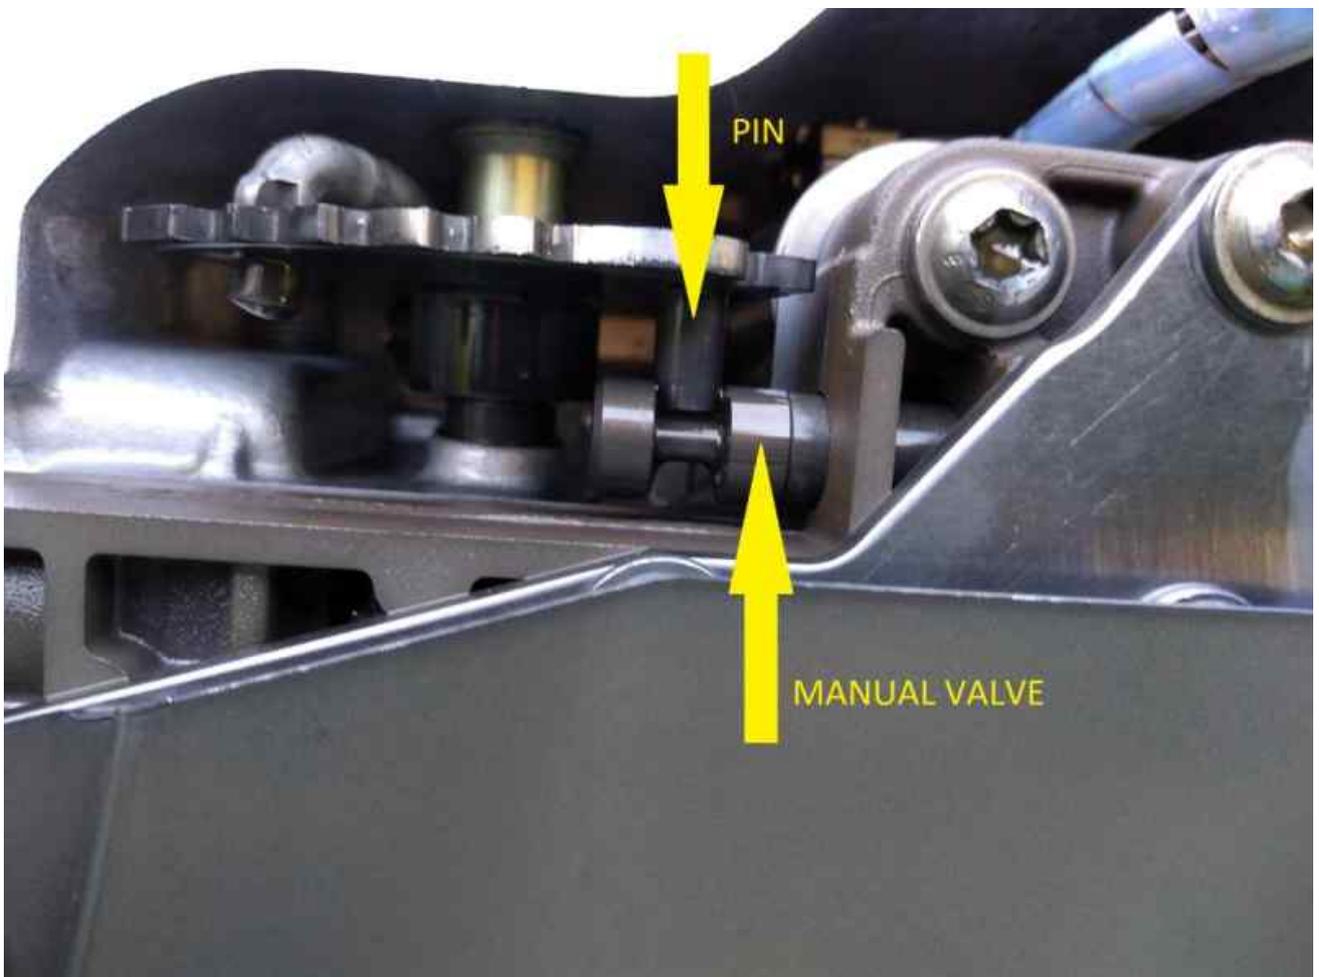
Important: ensure the manual valve is installed and that it is around the correct way.

With the axial slot visible! refer to picture #1

Important: Install the 2 electrical connectors for the electro-valves on the back side of the valve body before installing the valve body onto the transmission.

There is a pin descending from the selector quadrant. The pin must engage in the slot around the end of the manual valve. It does not matter where the quadrant or manual valve are located at this time just that the pin is located in the groove as the valve body is installed. Screw up the 2 mounting screws but not tight just yet. OK. confidence check!!

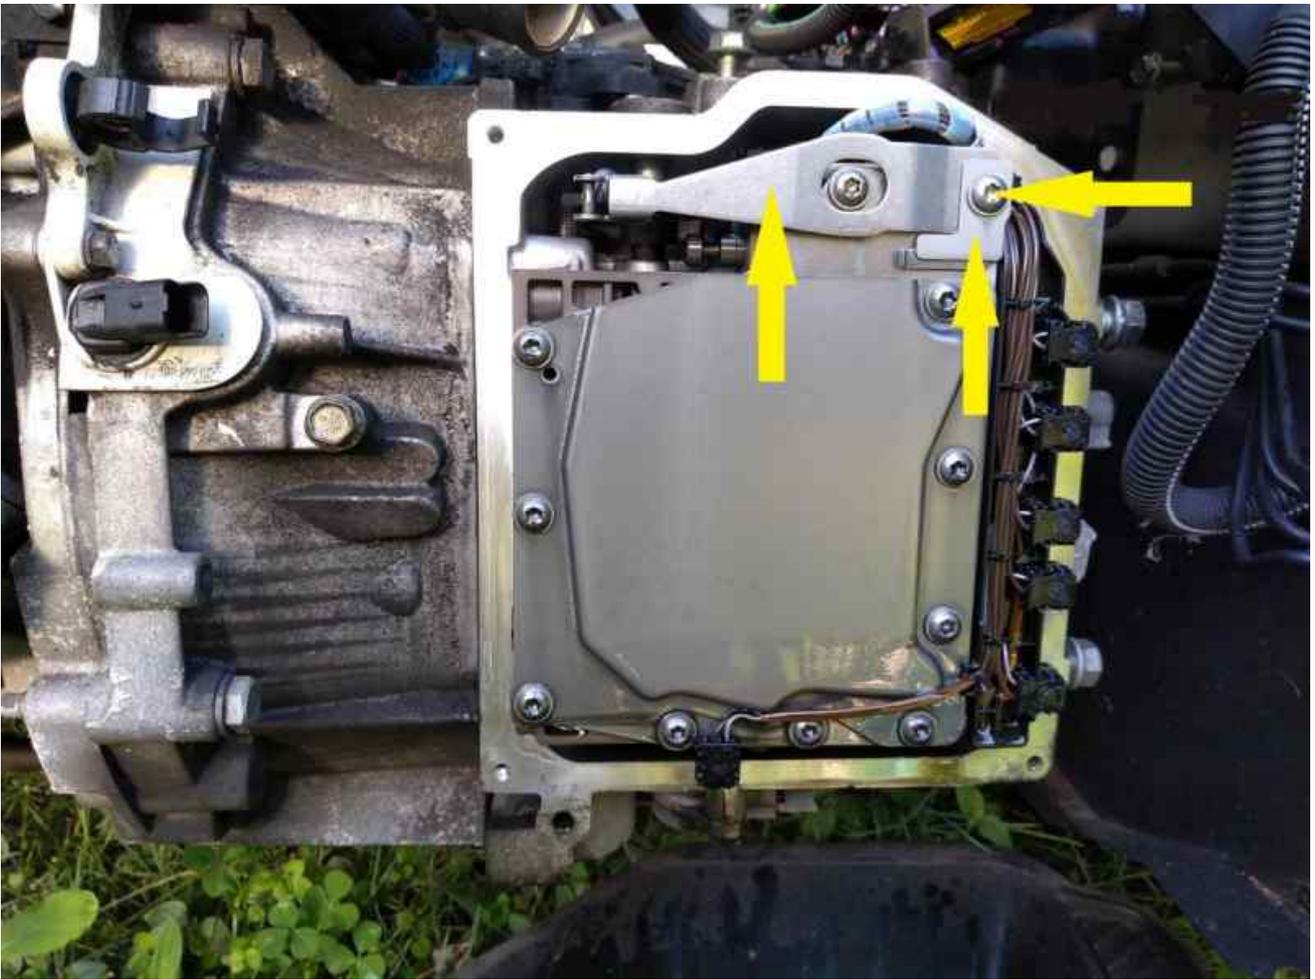
Re-install leaf spring, 'L' shaped washer and retaining bolt. Don't worry where the spring is located at this time and don't fully tighten the retaining bolt.

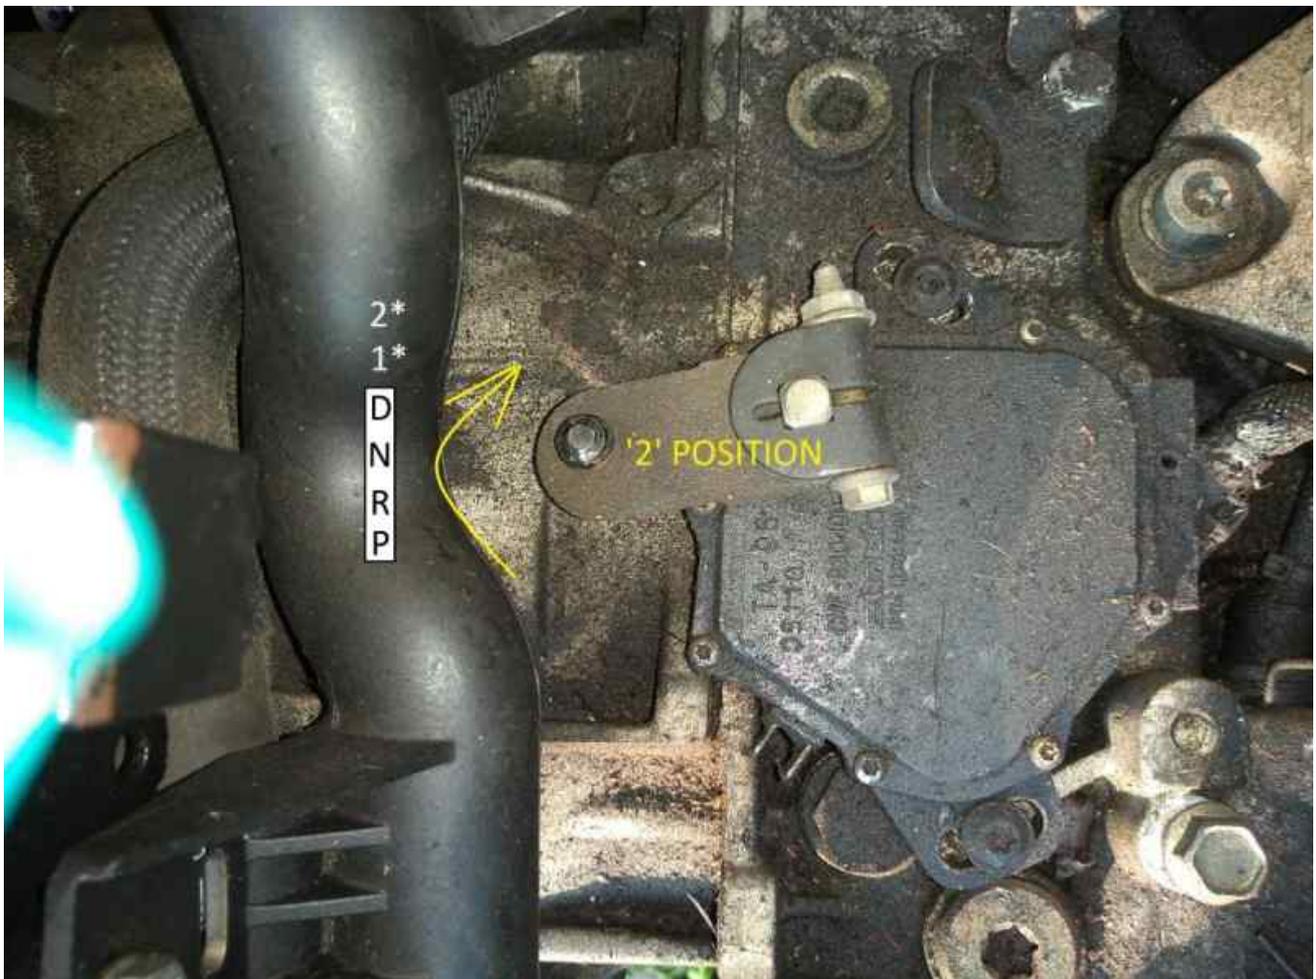
If you haven't already, pop the ball joint socket off the selector shaft. Rotate the selector arm all the way clockwise to the #2 position.

It is very difficult to explain what you need to achieve in setting up the relationship of the leaf spring and the detentes in the selector quadrant. But the selector quadrant needs to be hard up against the fully counter clockwise stop when the leaf spring locator is in the last detente of the selector quadrant.

Note: when the selector ARM on the TOP of the transmission is rotated counter clockwise, the selector quadrant inside the transmission rotates clockwise!!!!

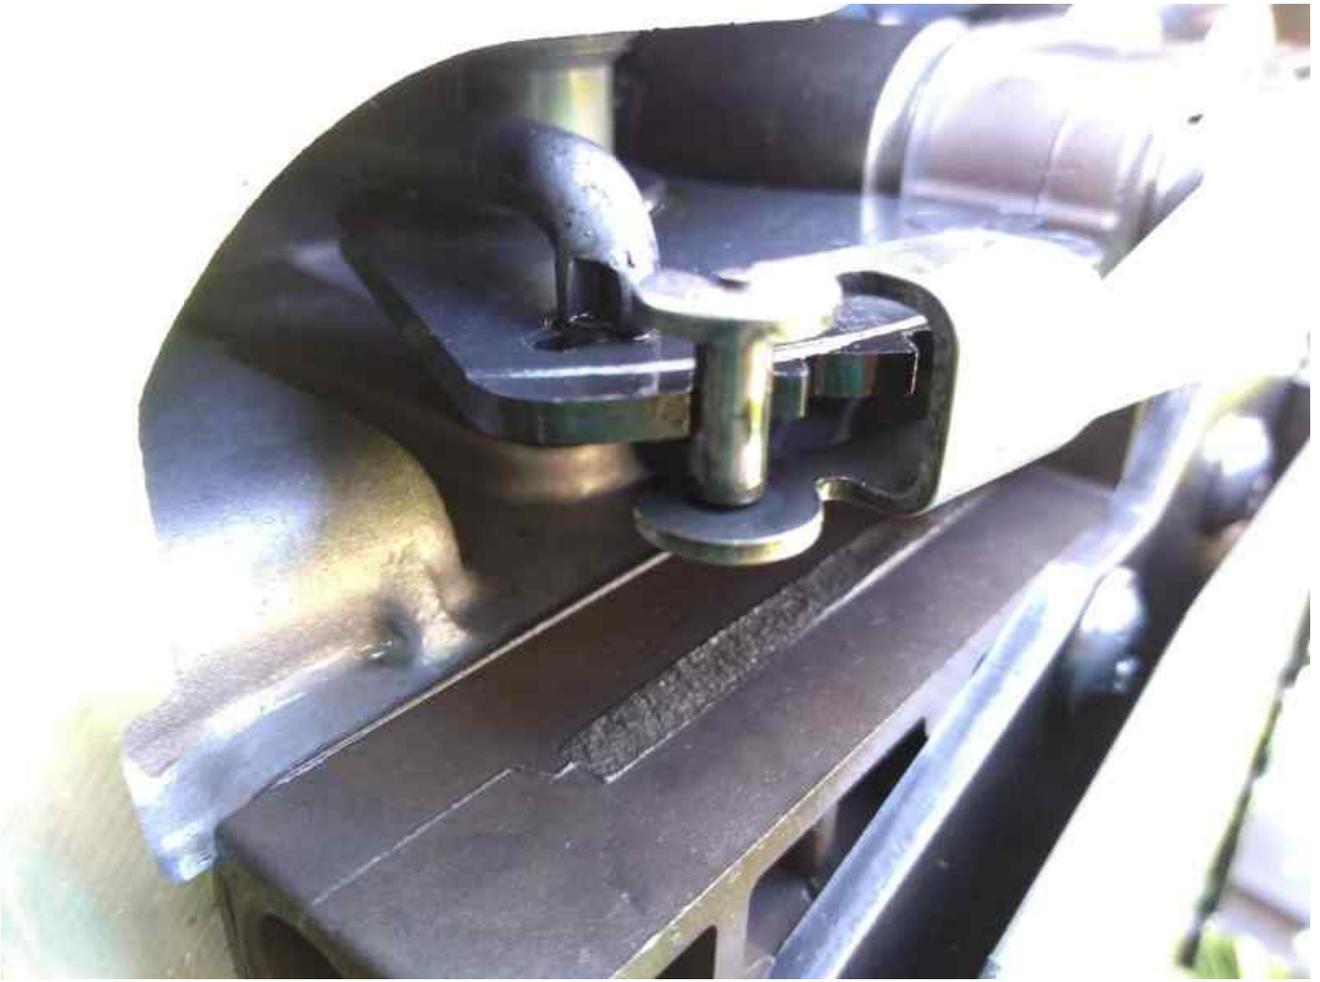
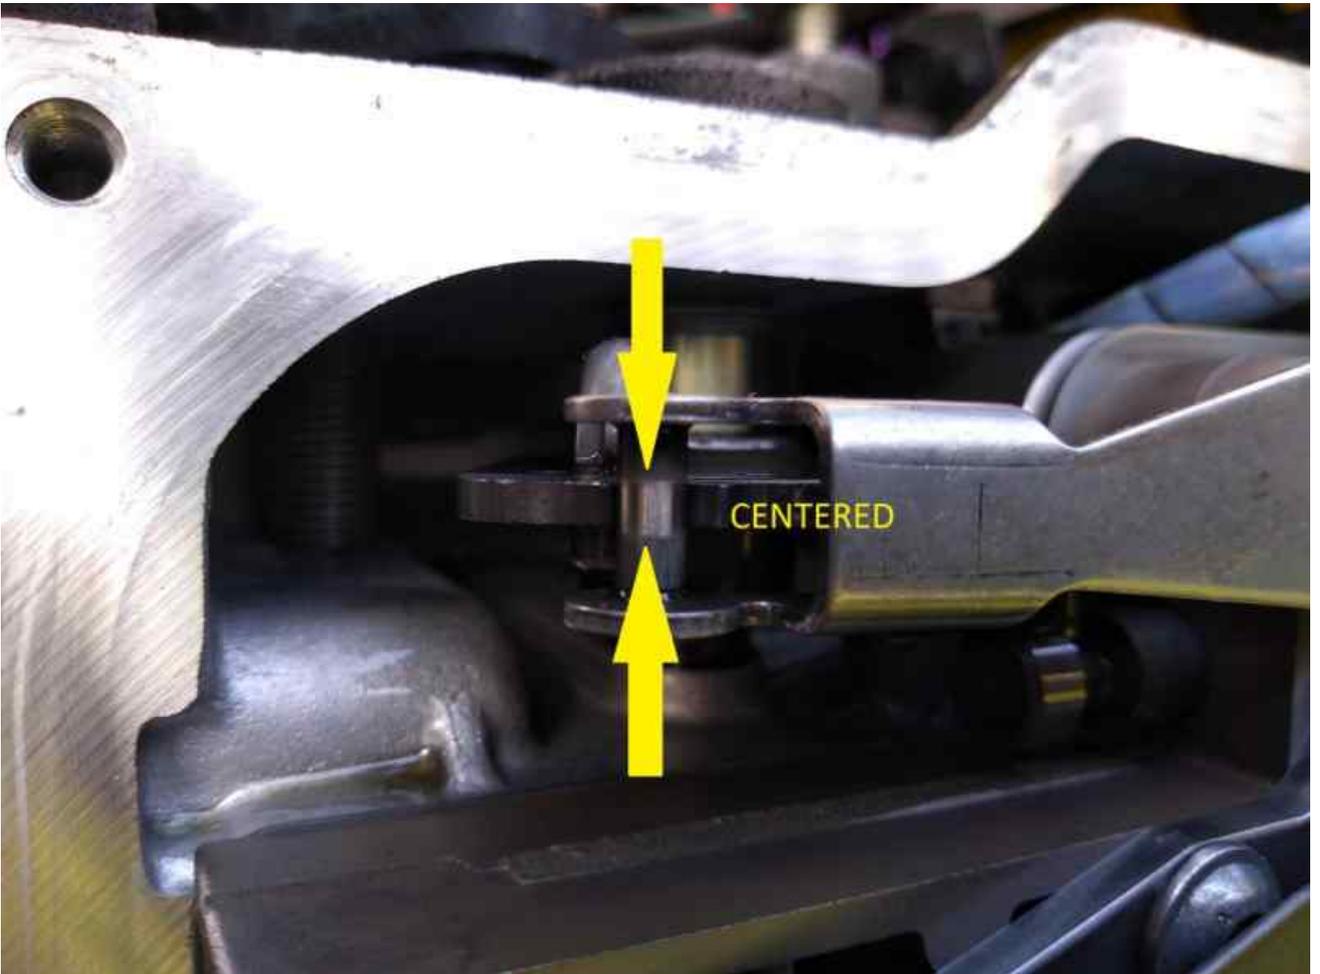
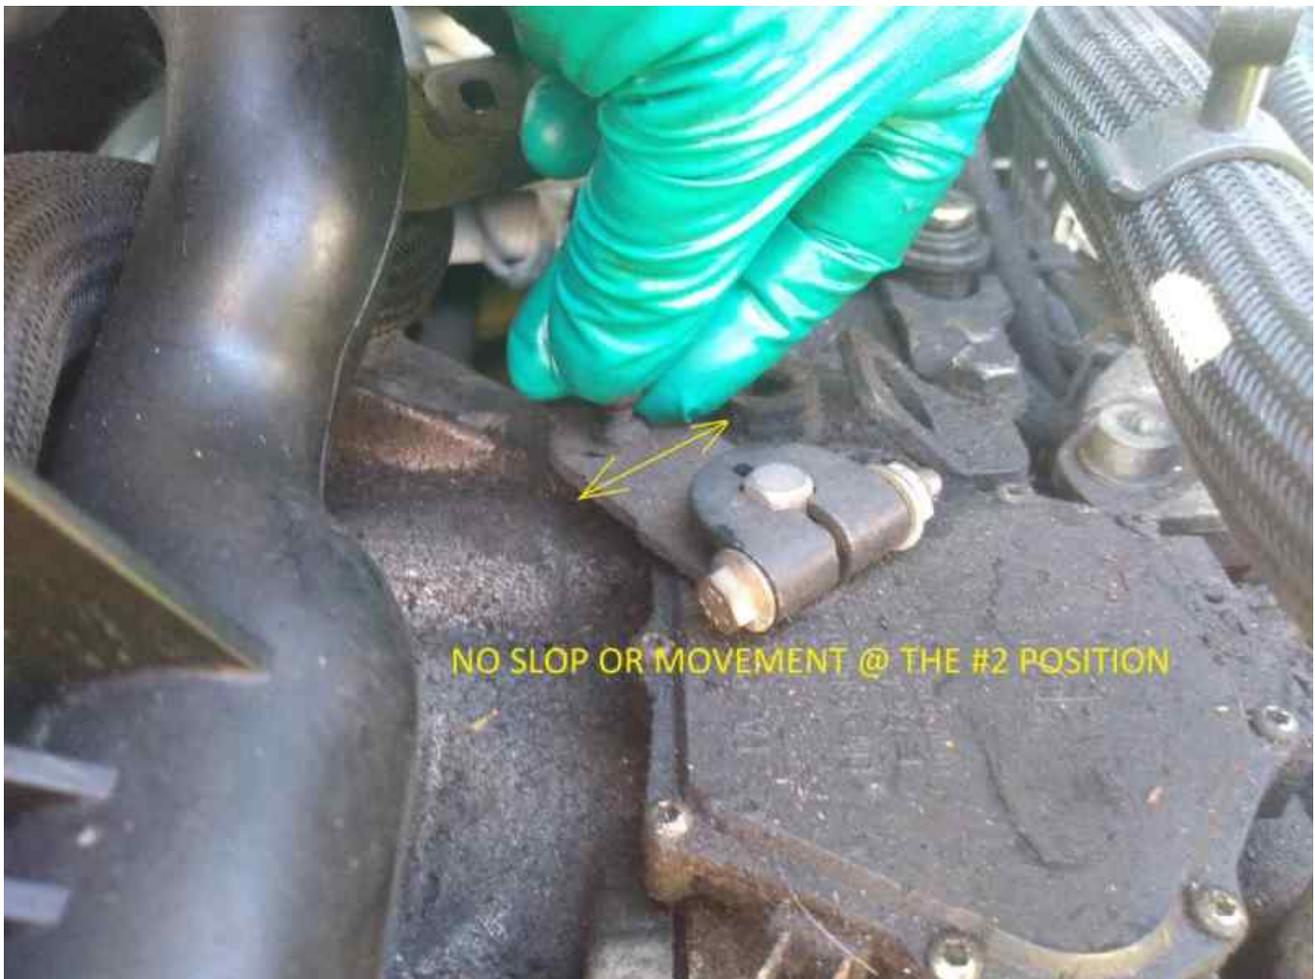
The problem is; that as you screw down the retaining bolt for the leaf spring it tends to push the quadrant off the stop and twist the leaf spring! There is a special tool that "squashes" (preloads) the leaf spring against the valve body and holds the spring in position as you make adjustments to the location of the quadrant and locator on the spring. The "locator" is the pin in the spring jaws that locate into the detentes in the selector quadrant. See picture 025a.

The process can be done without this special tool but you need to be aware of 2 things.

- 1) the spring locator needs to be (approximately) centered on the selector quadrant. Top to bottom.
- 2) when the spring is tightened down with the retaining bolt, there is NO slop in the selector arm at the #2 (fully CW) position.

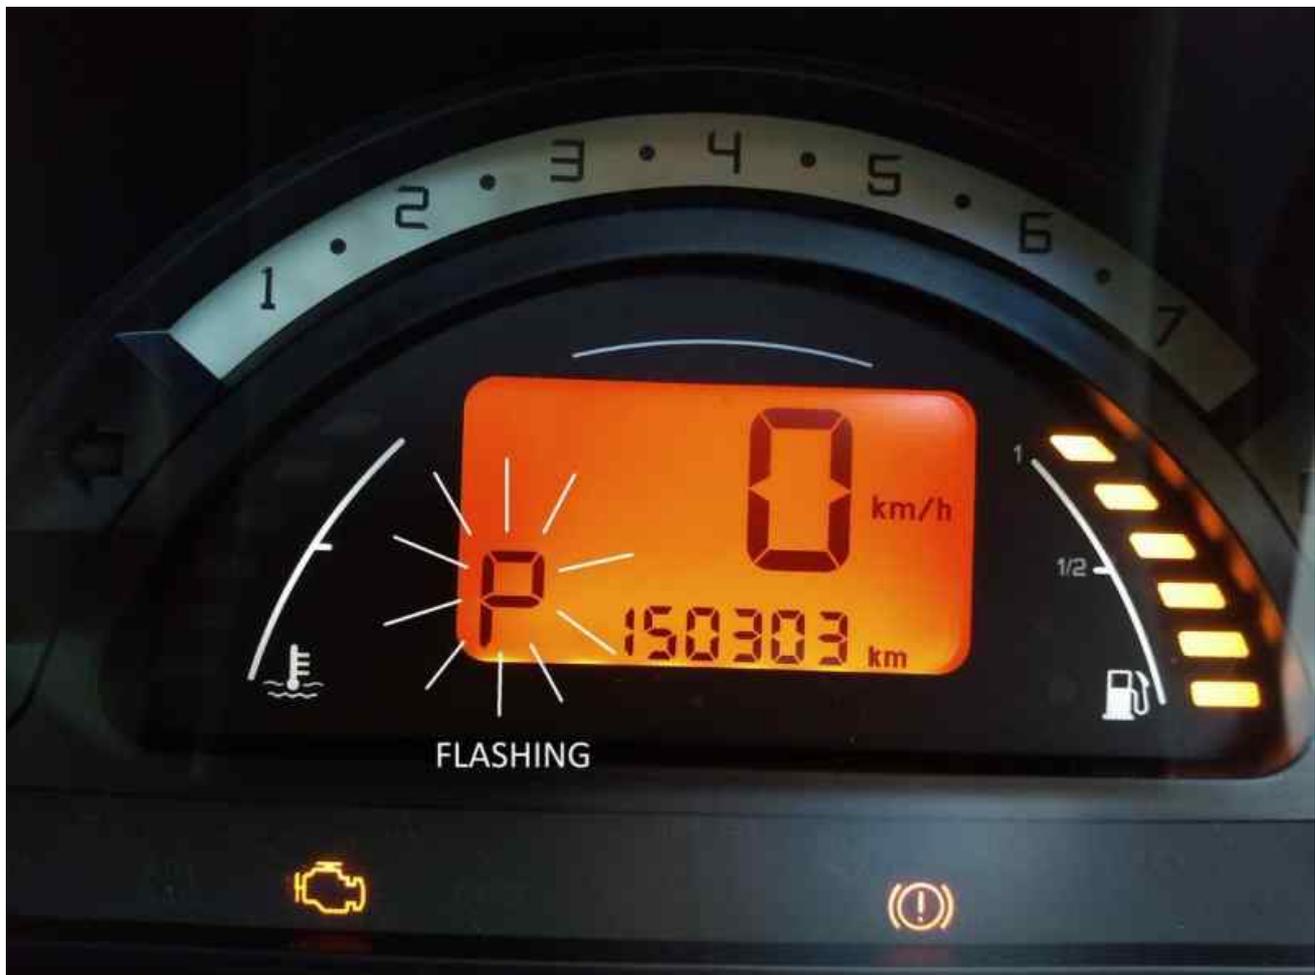
Rotate the selector arm on the top of the transmission to the neutral position. You can pop the ball joint back on and you can see if the alignment has been retained (only for those who don't want to do the alignment).

If (later) you put everything back together and the gear selector flashes when some positions are selected, then you will need to continue with the alignment. The quadrant and selector switch are out of alignment.

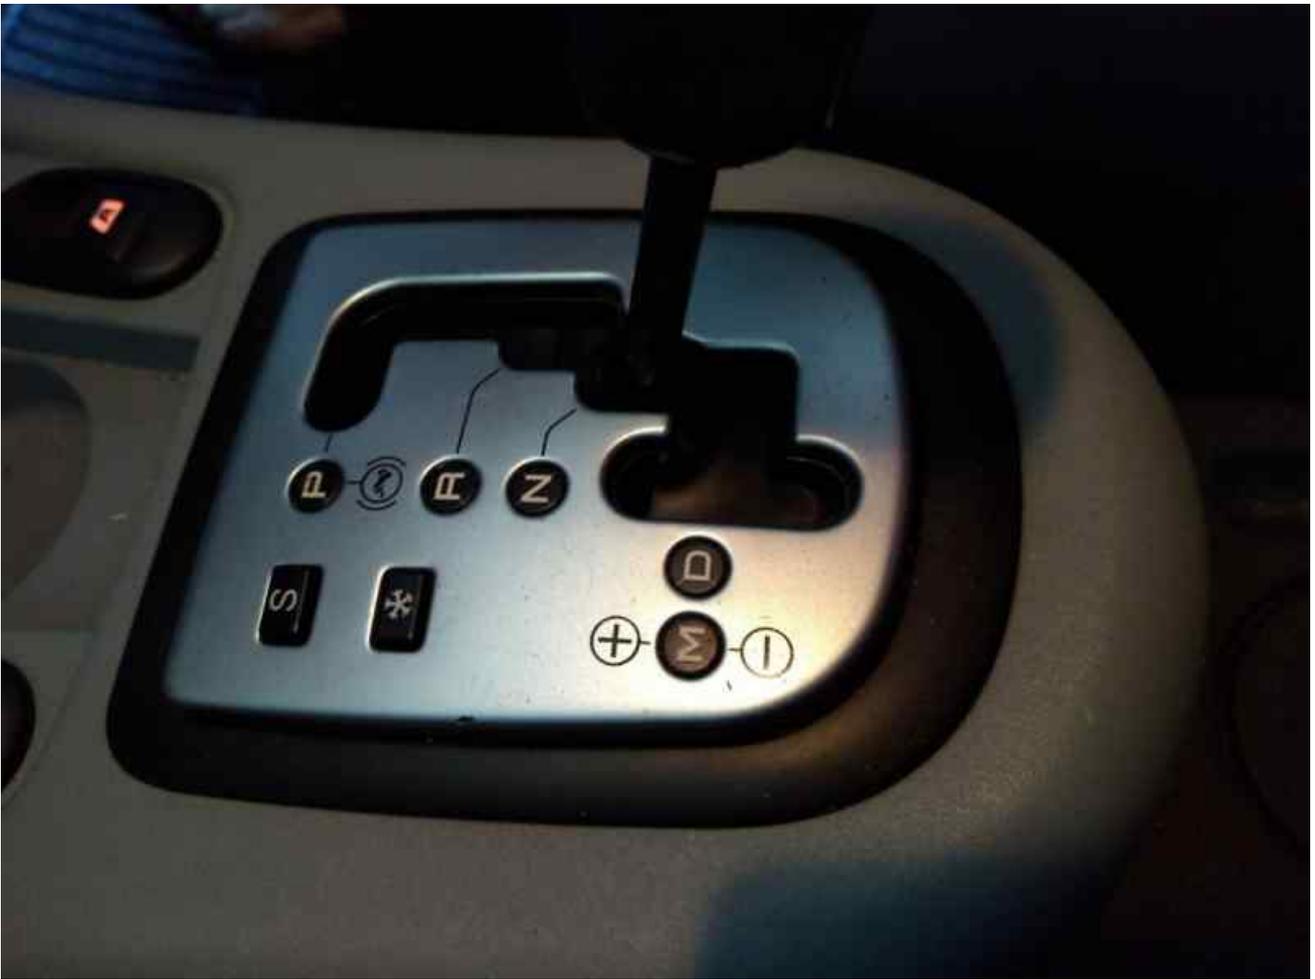
Make sure the gear selector in the cabin is in neutral. If necessary, rotate the selector arm on the transmission to the 'N' position.
