I have another way to perform the alignment of the selector quadrant and the leaf spring.

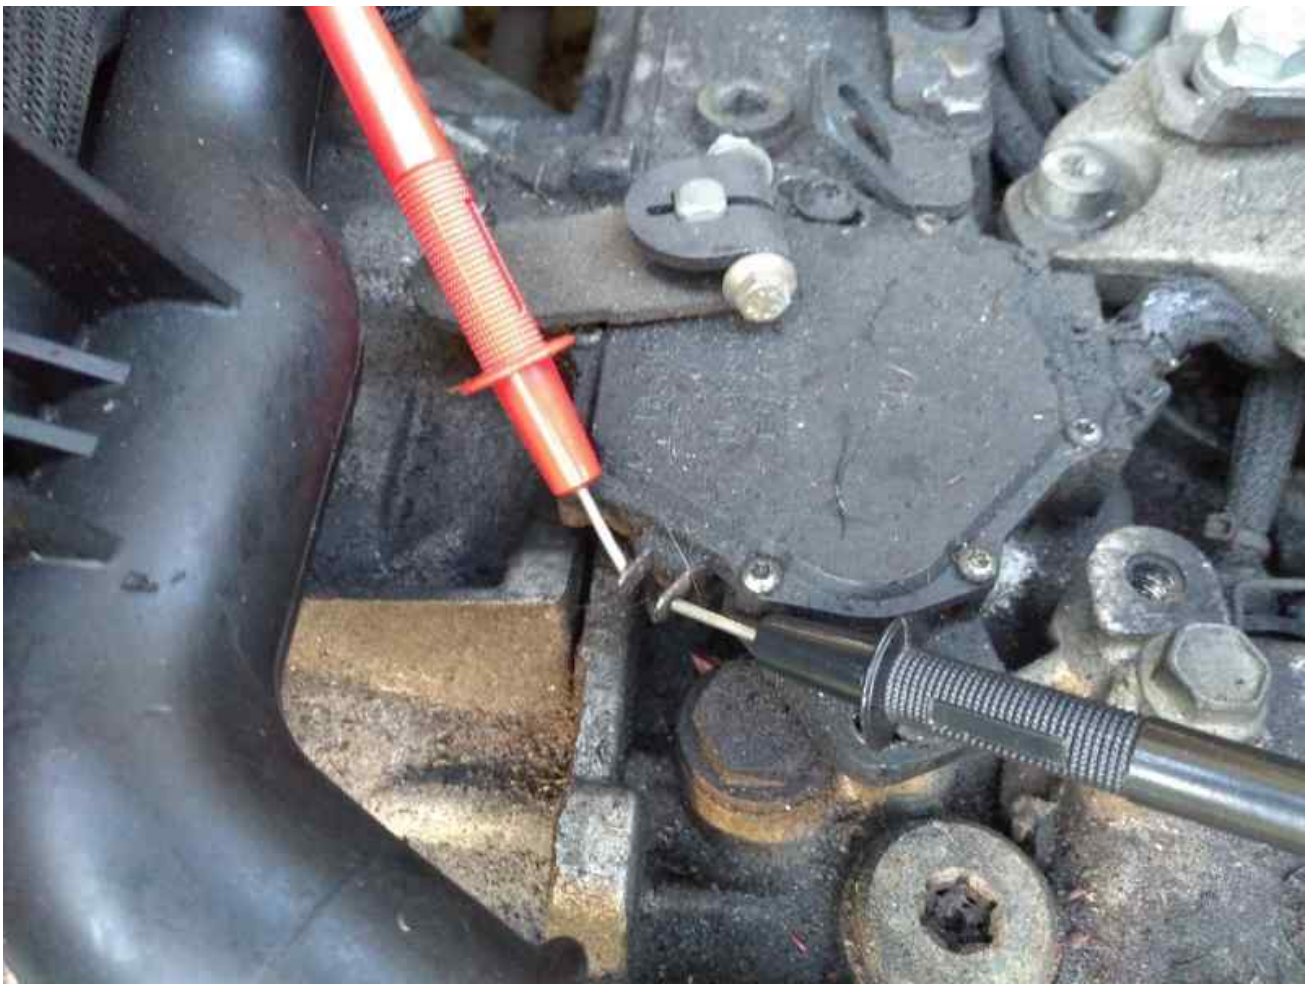
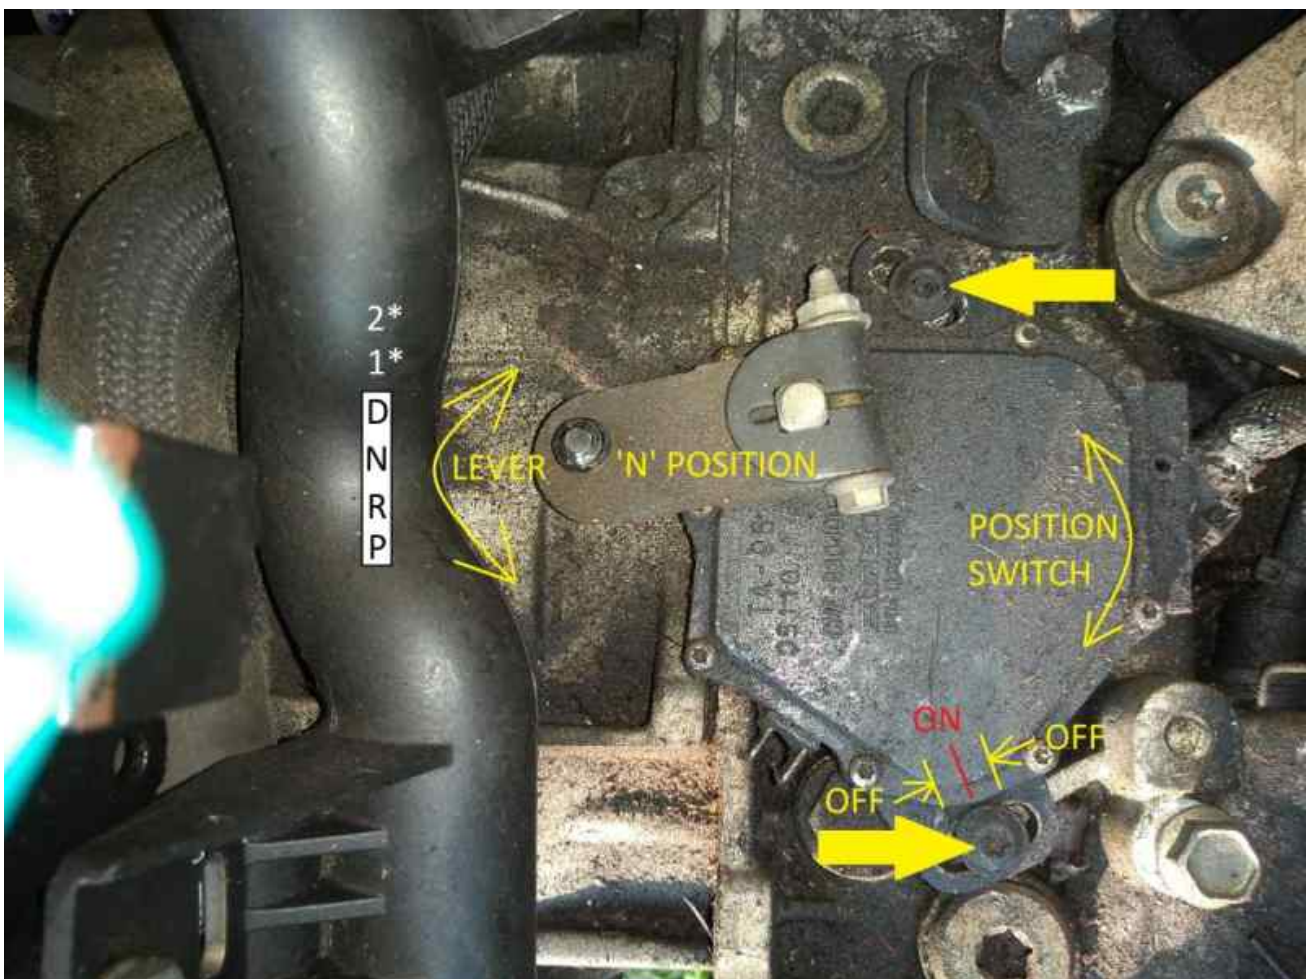
loosen the two retaining screws for the selector switch assembly so it can swivel around the selector arm shaft. Using a mulimeter or some device to check a short circuit, look for continuity across the two exposed contacts on the switch. Move the entire switch backwards and forwards to find the spots where the switch contacts are open circuit (off in the diagram). Find the mid point where there is continuity (on) and lock the two switch retaining screws down.

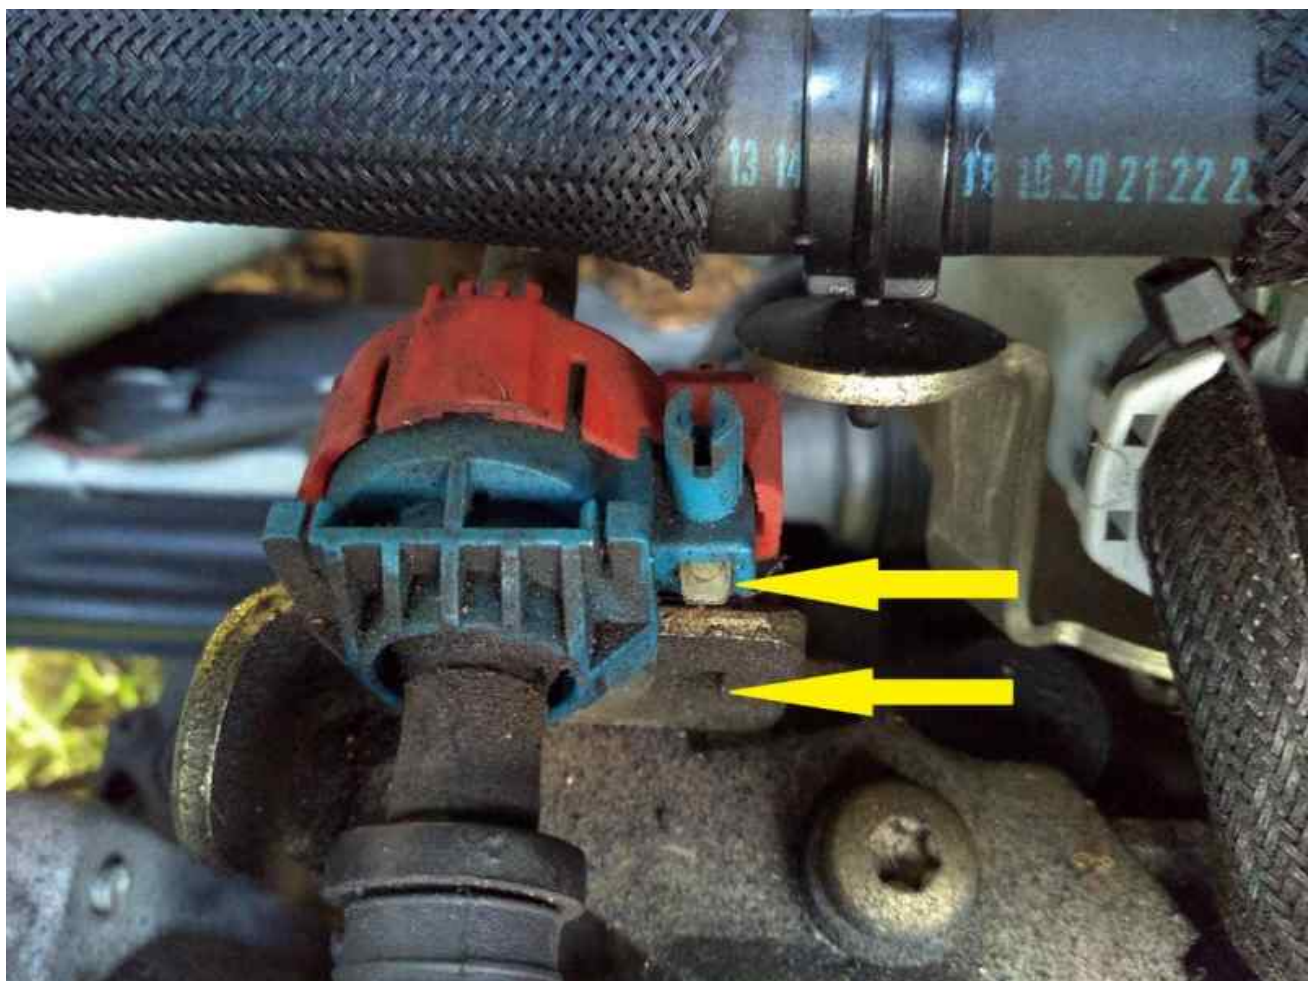
on the blue selector arm ball joint socket there is a yellow clip. Pull it upwards off the body of the socket. The socket is spring loaded on the shaft and it may pop outwards. Replace the cable retainer onto the bracket. Snap the ball joint socket back onto the selector shaft ball joint. Push the blue ball joint socket down until the two ears of the orange retainer pop out.

Push the yellow retainer back into the ball joint socket to lock the socket onto the selector cable.

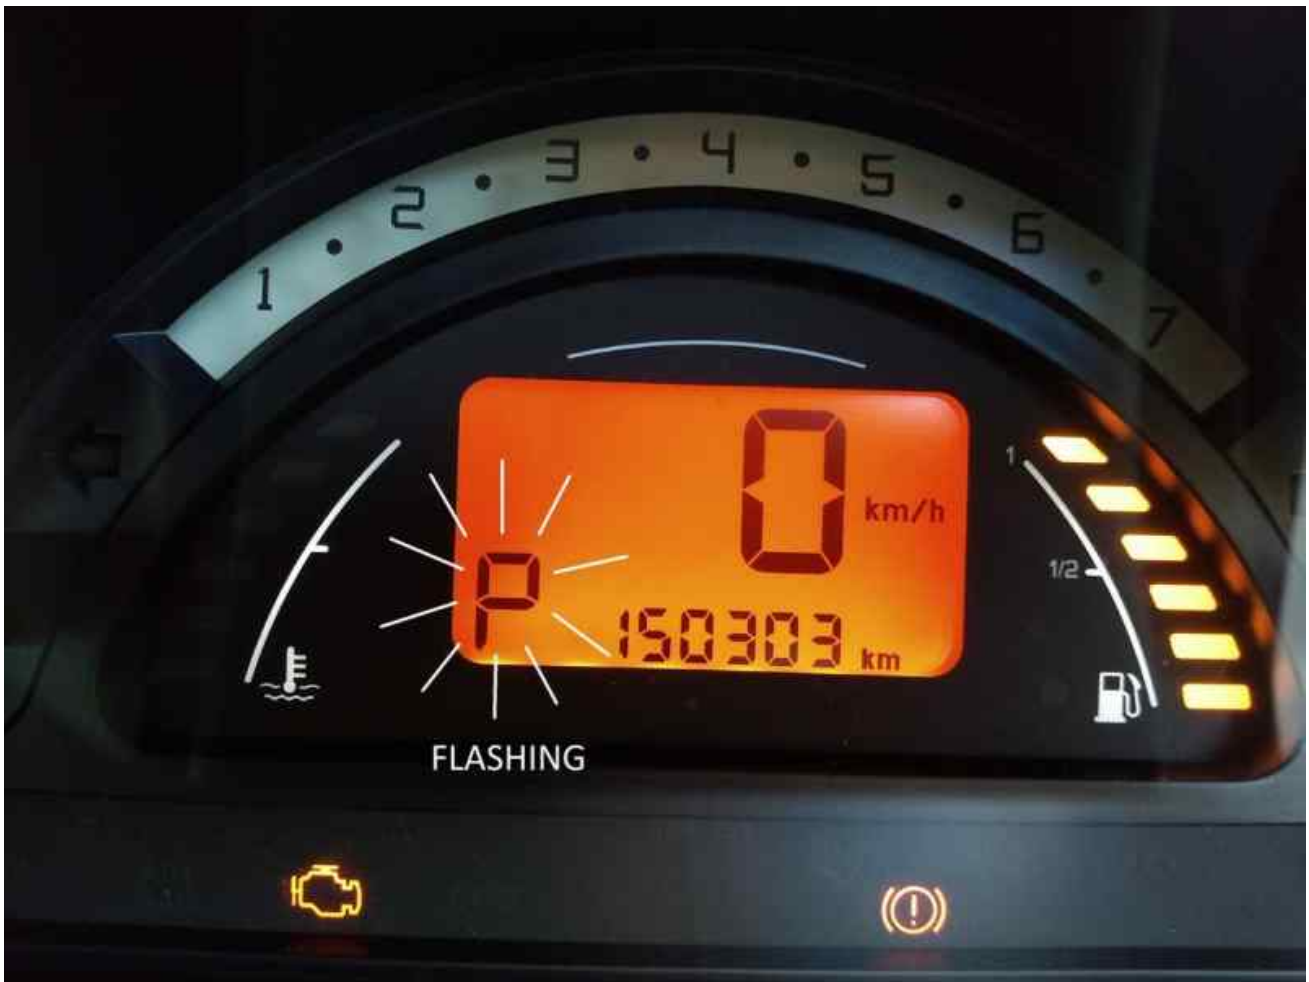
The final points are to install the coolant hoses (if removed), fill the engine with coolant (if required) and to re-fill the transmission oil. Sorry but as I explained in the beginning, I wont be covering that.

Finally, It's possible that after replacing the ball joint onto the switch arm your gear selector display will flash. If so try re-positioning the switch using the above alignment procedure...again.

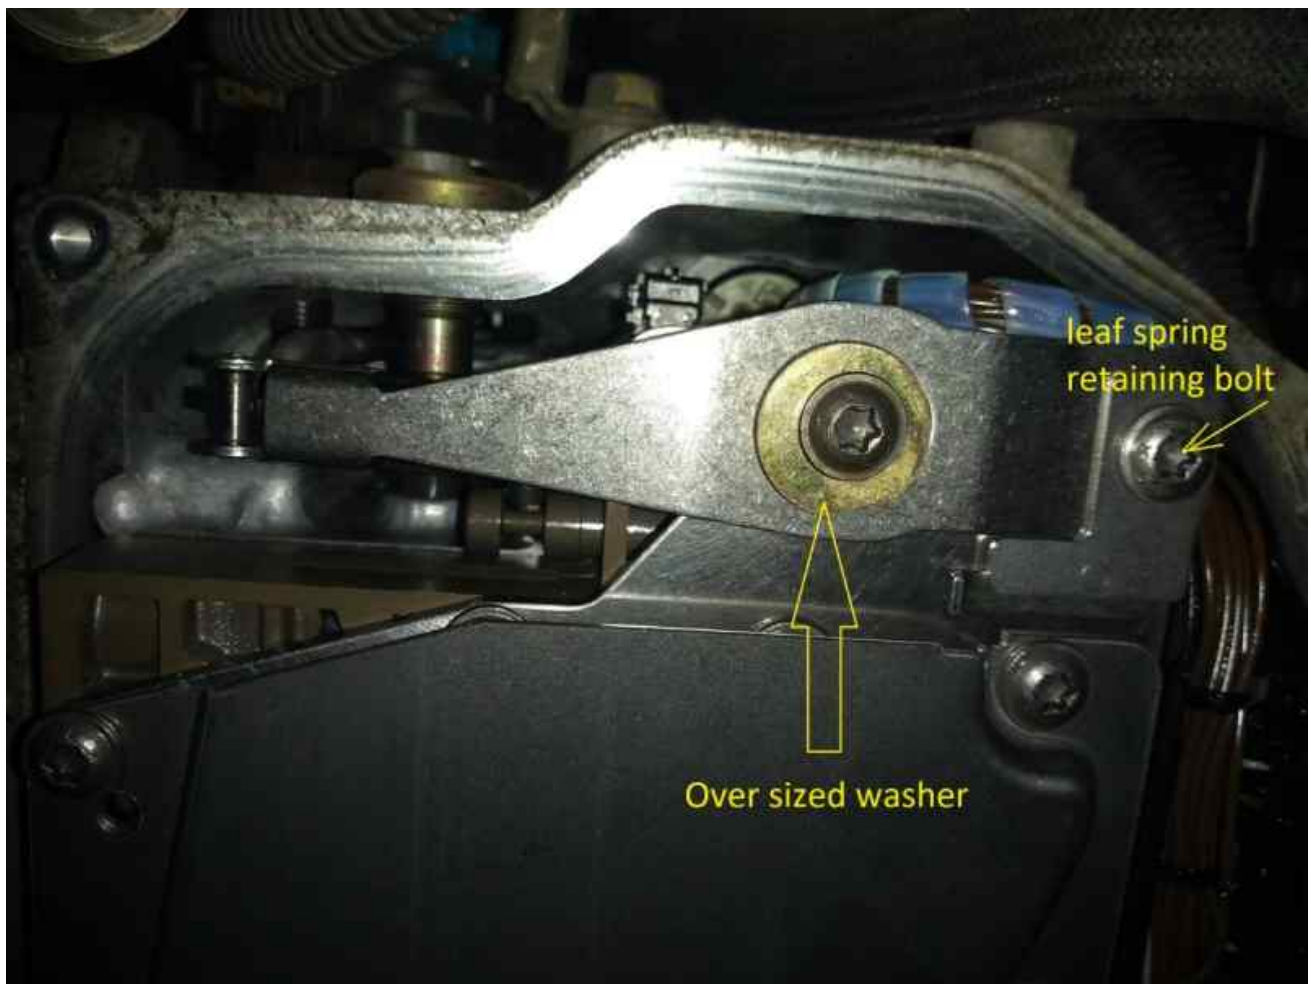
Remove the bolt that is visible through the hole in the leaf spring. Place an over sized washer under the head of the bolt and reinstall it. Screw the bolt down until the leaf spring is flat against the valve body and the bolt is tightened down (just tight, not too tight). Make sure the detente roller is engaged in the number 2 position (the last notch on the left of the selector quadrant). Undo the bolt with the over sized washer, 2 whole turns. The leaf spring is now preloaded with the same tension as if the retaining bolt was tightened up.

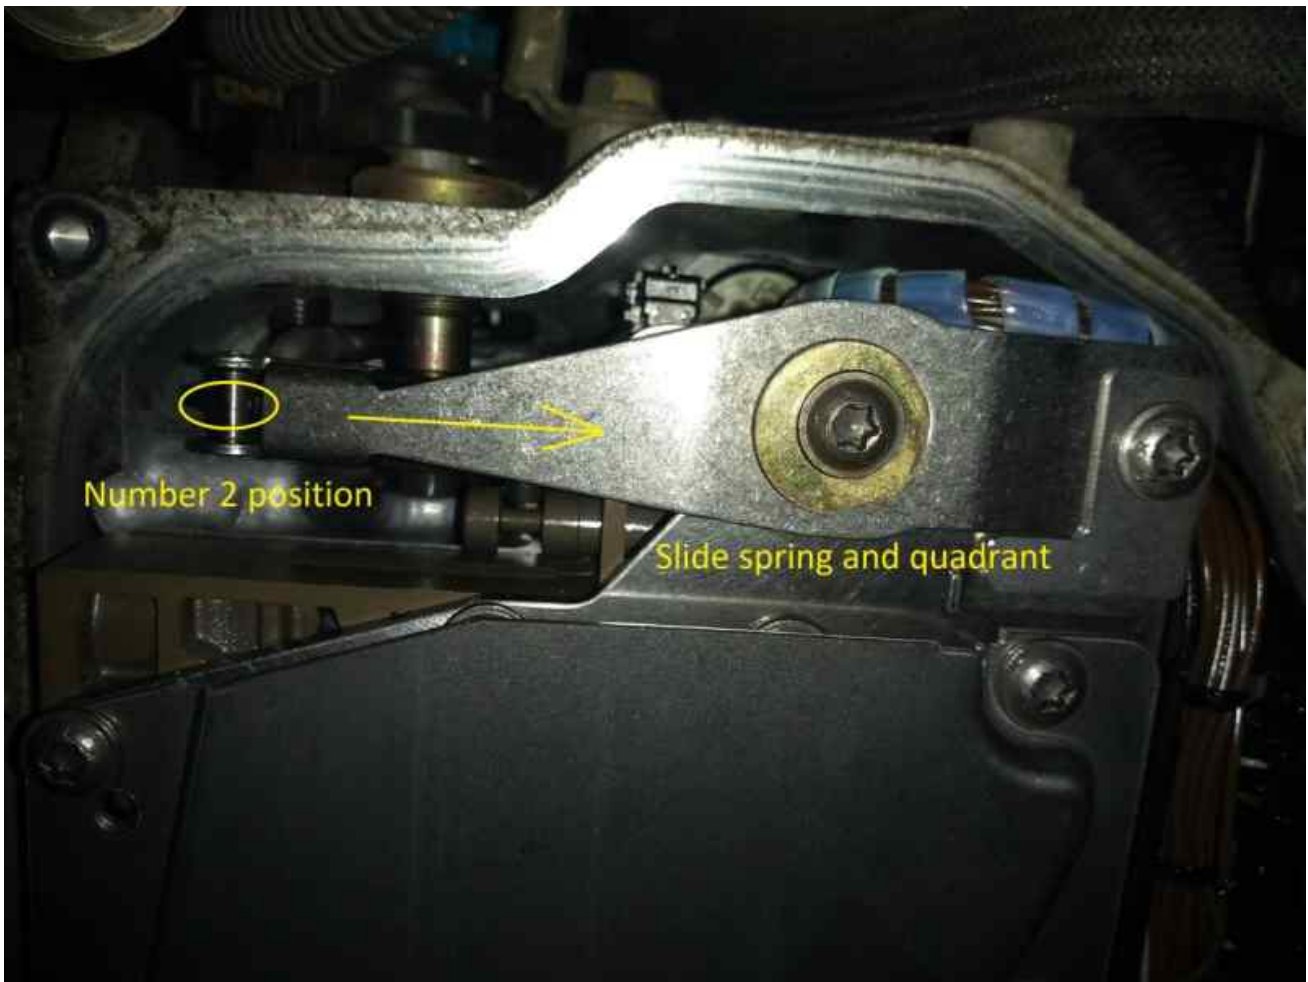
Now slide the leaf spring and selector quadrant to the right until the selector quadrant is hard up against it's stop and stops moving.

Tighten the spring retaining bolt to 9 Newton meters. Remove the washer and bolt. Remove the washer from the bolt and reinstall the bolt into the valve body. Torque it to 7.5 Newton meters.
